2000 S TYPE CLIMATE CONTROL REMOVAL INFORMATION

Center Control Console Removal

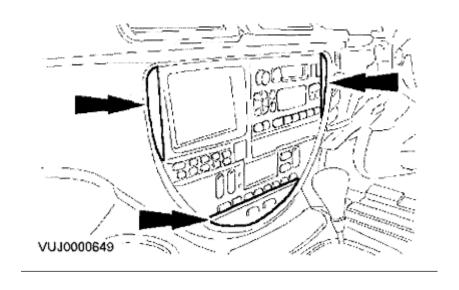
1. Remove the center control panel screw covers.

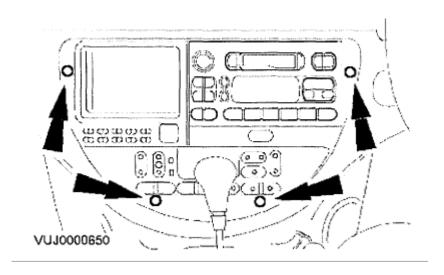
Detach the center control panel.

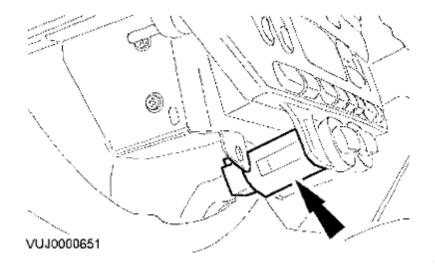
Disconnect the heated seat electrical connectors

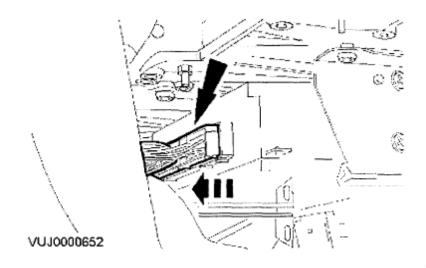
Disconnect the climate control unit electrical connectors

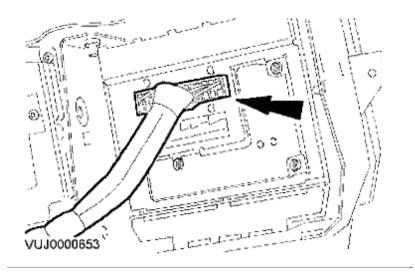
Disconnect the satellite navigation screen electrical connectors ,lf applicable

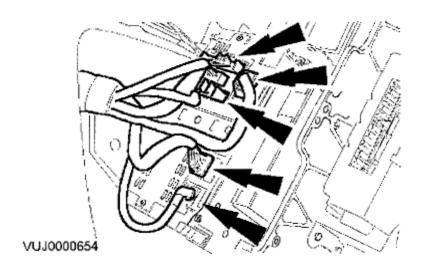
Remove the center control panel. Disconnect the audio system electrical connector.

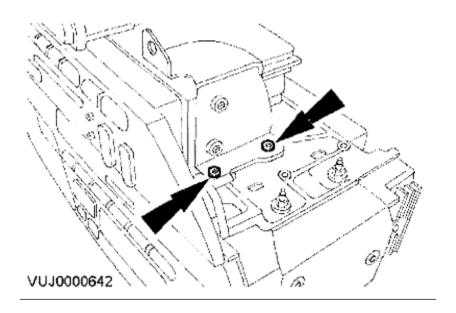
Remove the control assembly screws

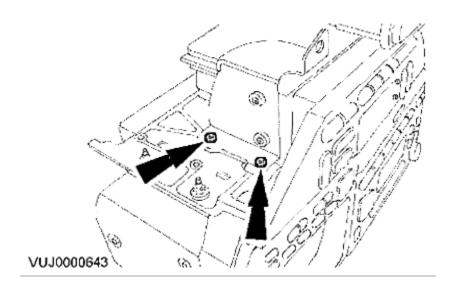
Remove the control assembly screws

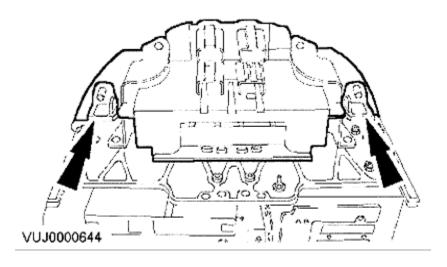
Remove the control assembly
